# 1.000 Bearings Failed – Who is to Blame?

Ing. Jiří Valdauf, Ing. Jozef Šiška, Ing. Martin Legner  
LUBRICANT s.r.o., Czech Republic  
[valdauf@lubricant.cz](mailto:valdauf@lubricant.cz), Mobile: 777 345 007

**LUBRICANT EXPO  
THE BEARING SHOW**

**Düsseldorf 17 - 19th September 2024**

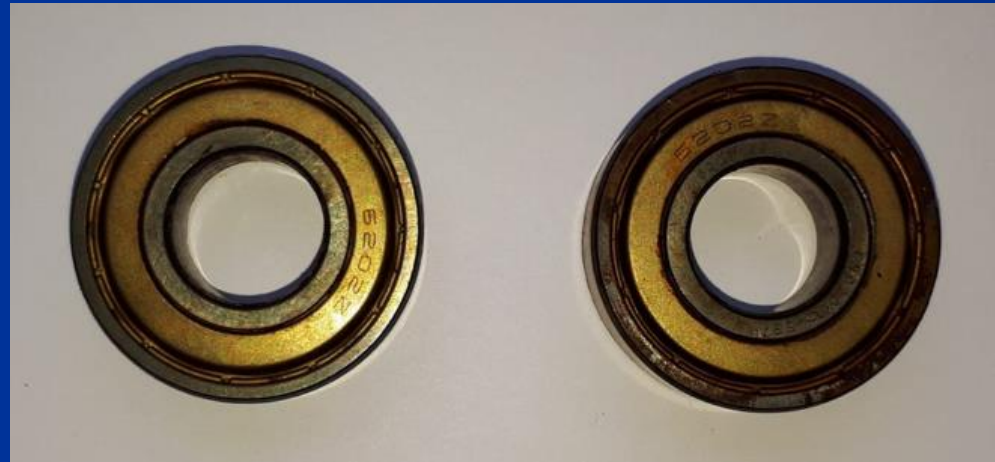
## ? Grease in Bearings?

- The laboratory of LUBRICANT s.r.o. got an order to analyze, what caused bearing failure.
- Both bearings were stucked.

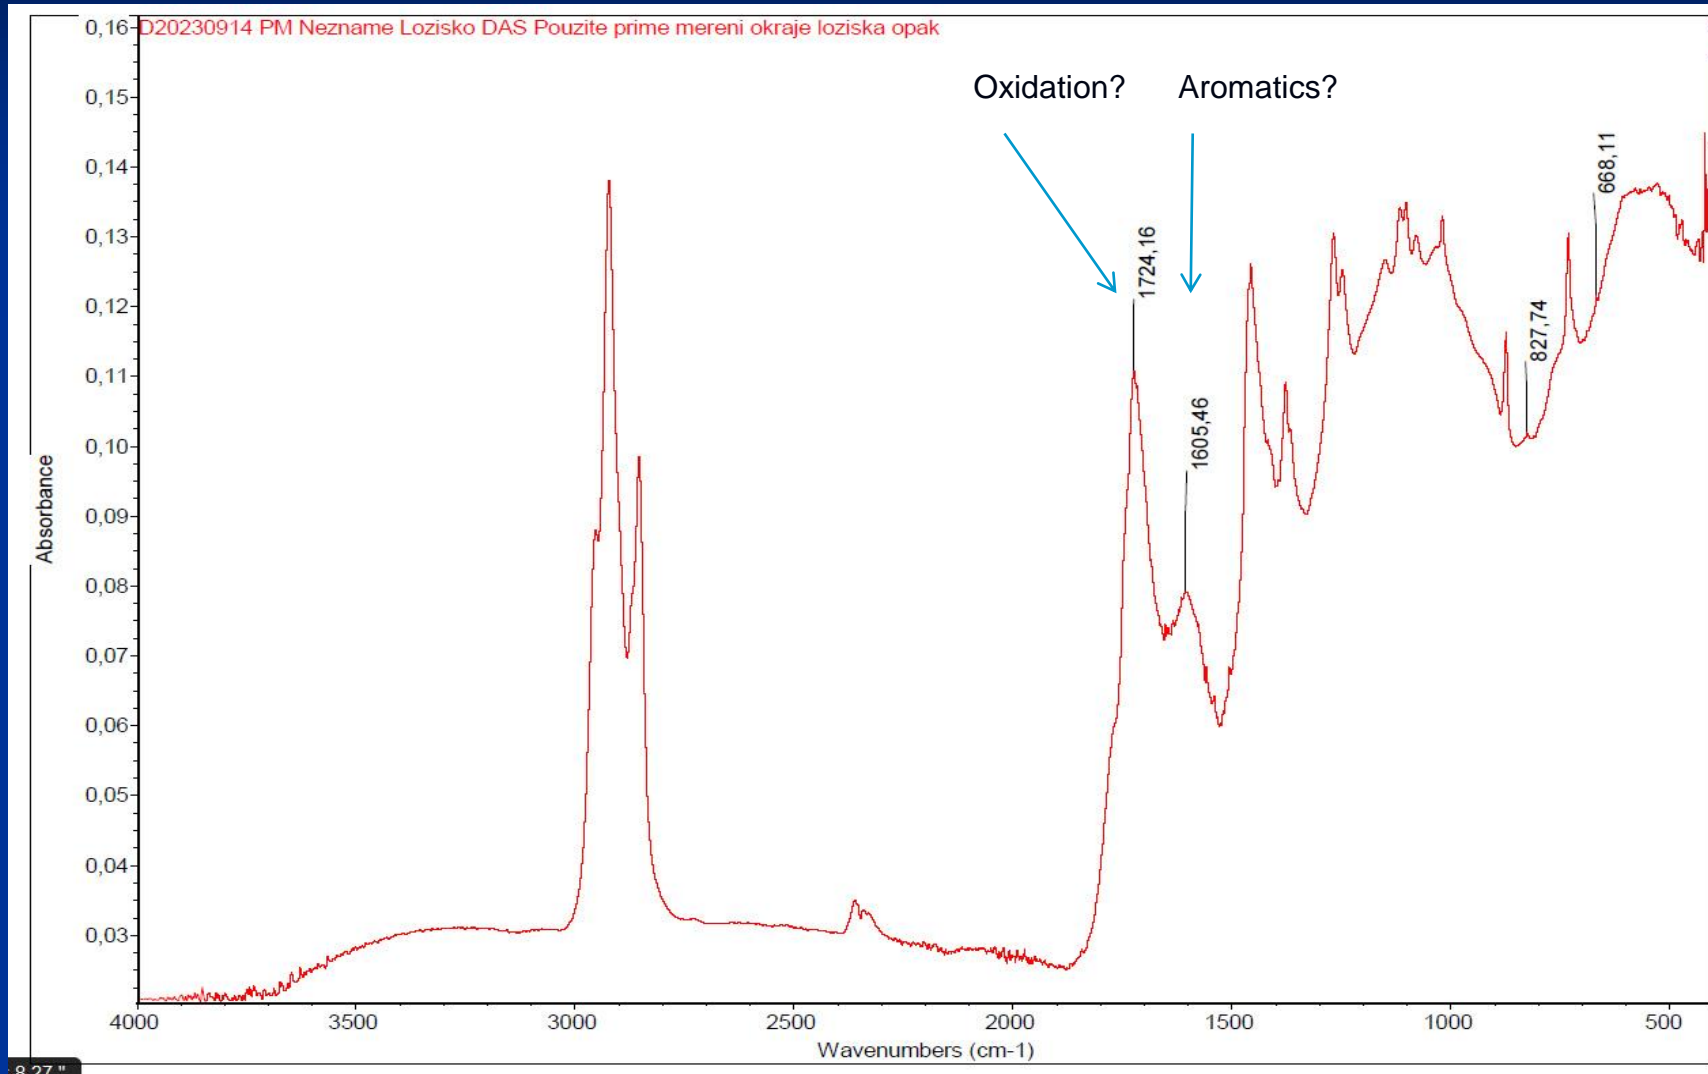
# FTIR ATR Analysis of Disassembled Bearing

- No grease residue was found in the first bearing.
- Small volume of deposits from the second bearing was analyzed by FTIR ATR – only oxidation products ( $1724\text{ cm}^{-1}$ ) and aromatics ( $1605\text{ cm}^{-1}$ ) were evaluated.
- No metal thickener was identified by OES-ICP, low Ca concentration shows on traces of corrosion preventive, based on calcium sulphonate in the second bearing.

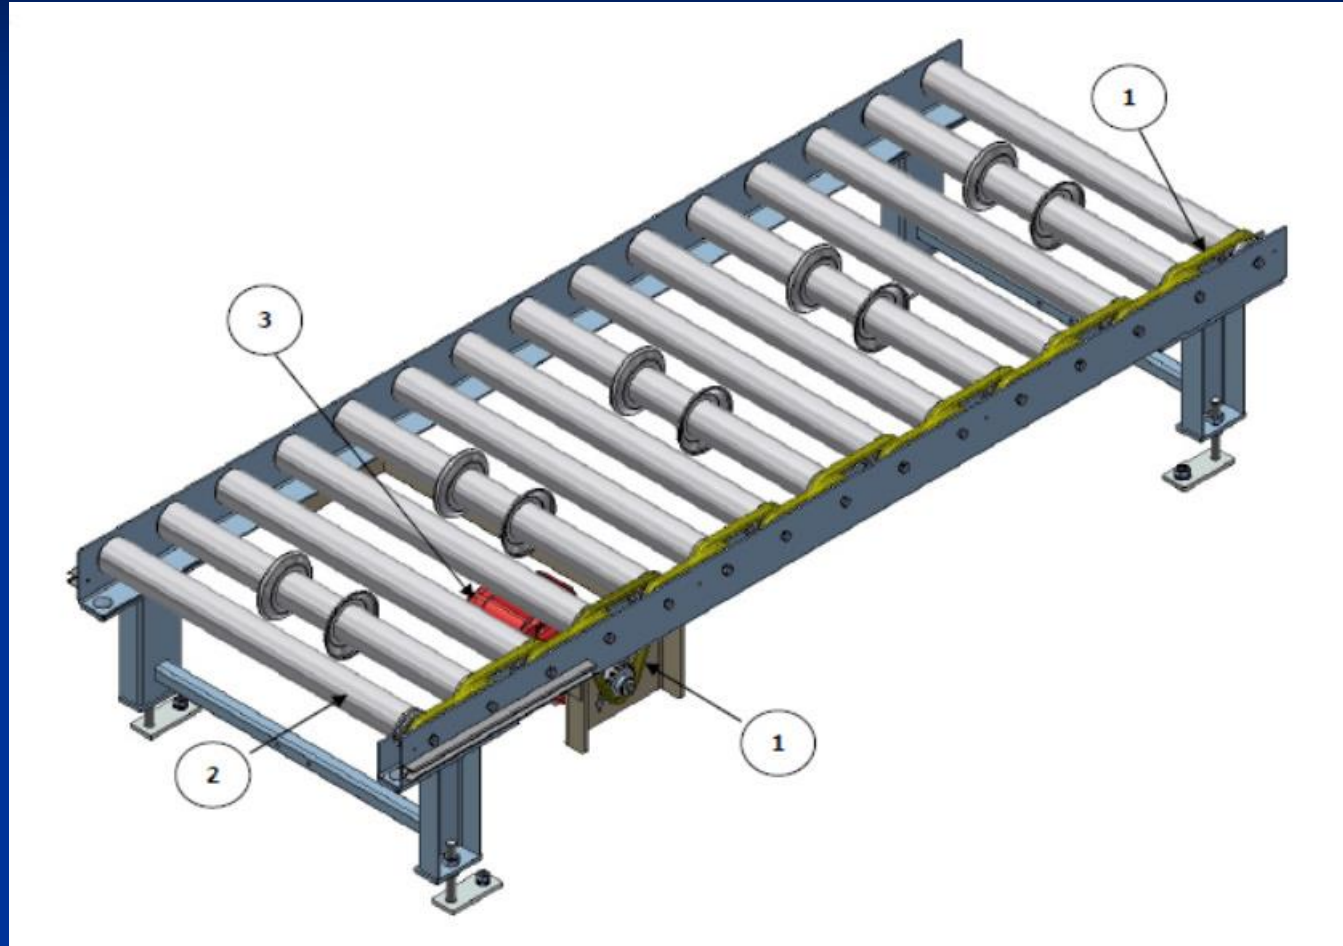
# Drying Oven for Plastisol Application

Temperature = 160°C

Oven length = 31 meters

Time of appl. = 40 minutes

Bearing 6202ZZ for 200°C  
inside of 500 rollers

Hundreds chains

4 transmission gears

Everything was placed inside  
of the oven, in hot area

- Wrong design of drying oven – lubricating contacts should be outside of drying oven
- All lubricating places should be designed with the possibility of relubrication
- Polyurea grease could work properly, if is there a possibility of relubrication
- -----
- 1000 new bearings with higher corrosion resistance were assembled. Extremely expensive fluorinated lubricants were filled in. It works properly for 1 year now.

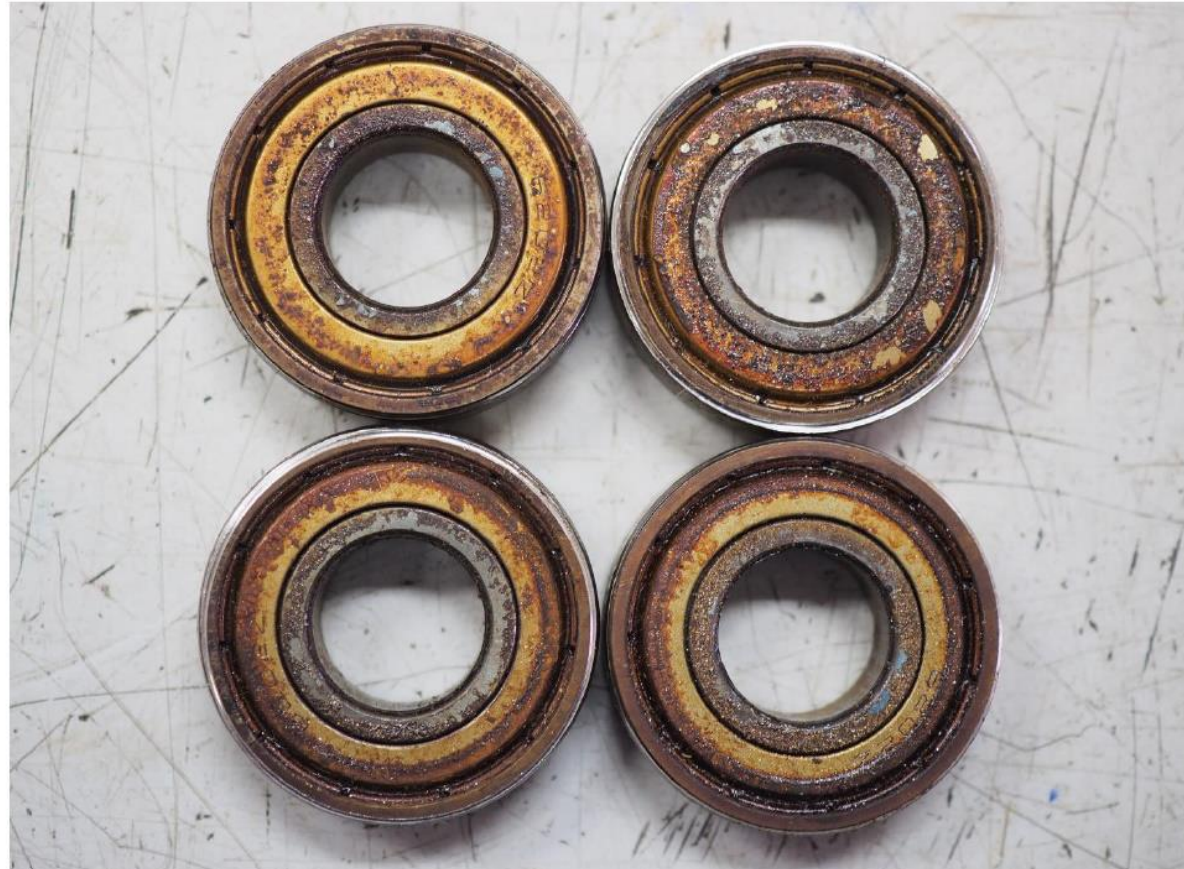
# Stucked Bearings after 3 Month of Operation

Bearings  
6202 ZZ  
ENC200°C

Vizuální kontrola ložisek 6202ZZ ENC200°C SPAIN, kontaminovaná strana – ulpívající fragmenty degradovaného plastického maziva

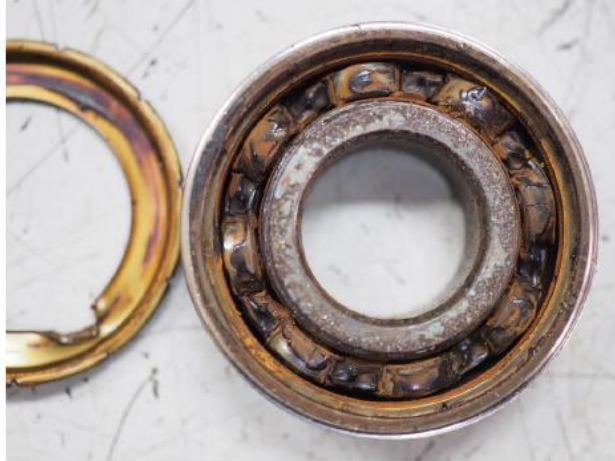
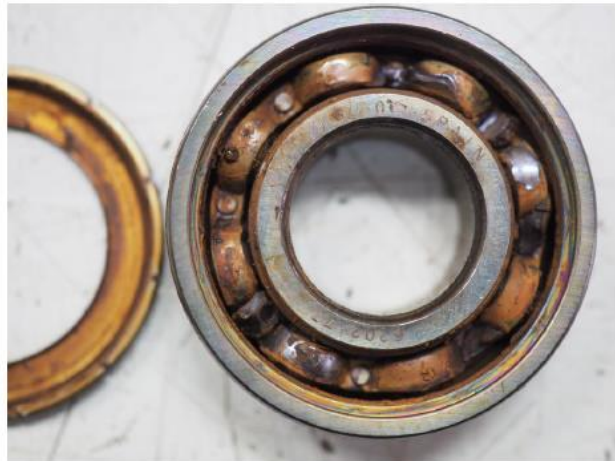
# Stucked Bearings after 3 Month of Operation

Vizuální kontrola ložisek 6202ZZ ENC200°C SPAIN - vnitřní prostor ložiska znečištěný degradovaným plastickým mazivem

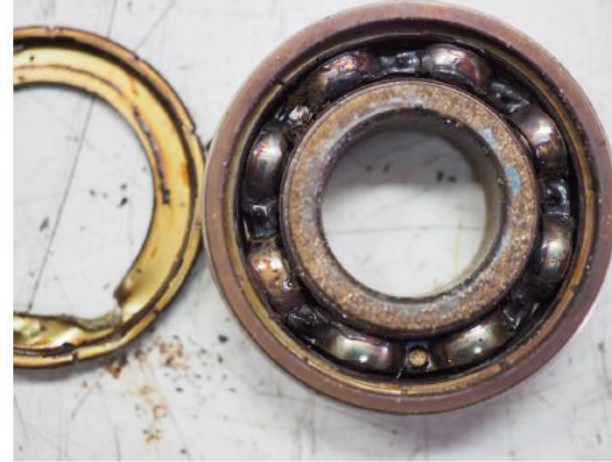
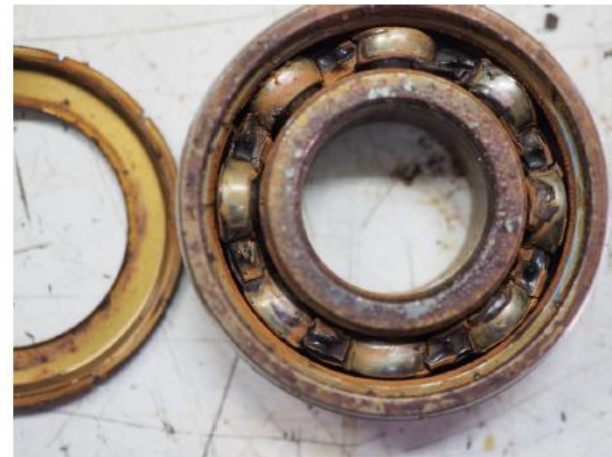
Vizuální kontrola ložisek 6202ZZ ENC200°C SPAIN - vnitřní prostor ložiska znečištěný degradovaným plastickým mazivem

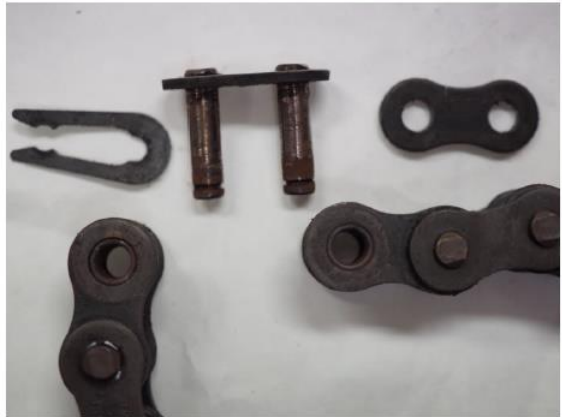
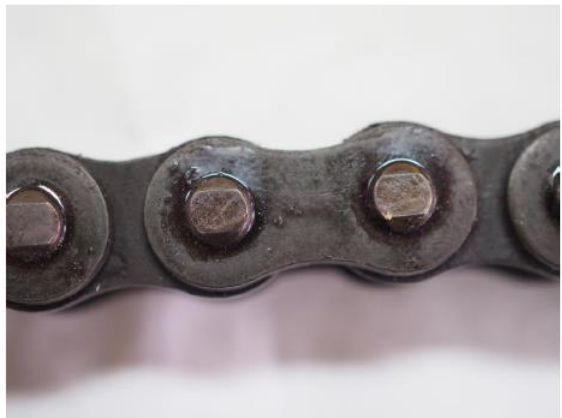
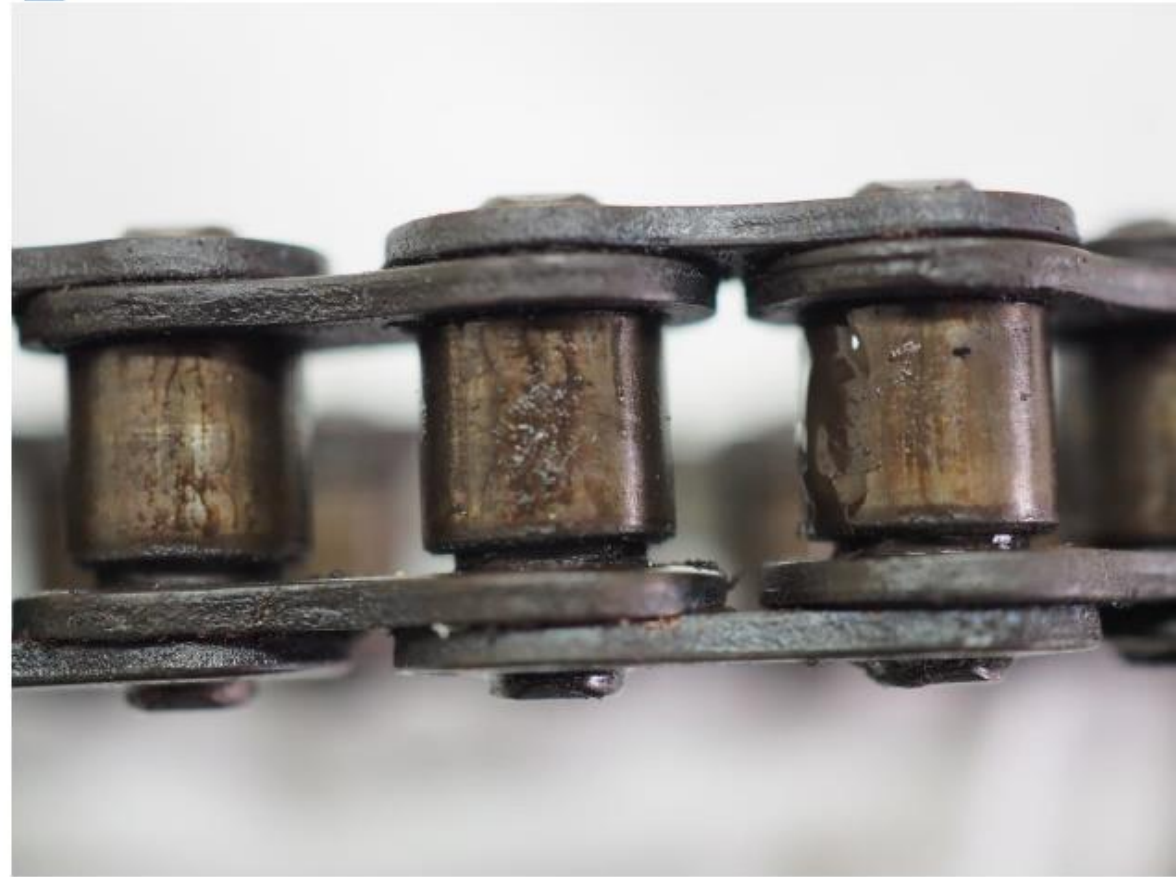
# Stucked Chain after 3 Month of Operation

Příloha 8 – Fotodokumentace řetězu pohánějící dopravník

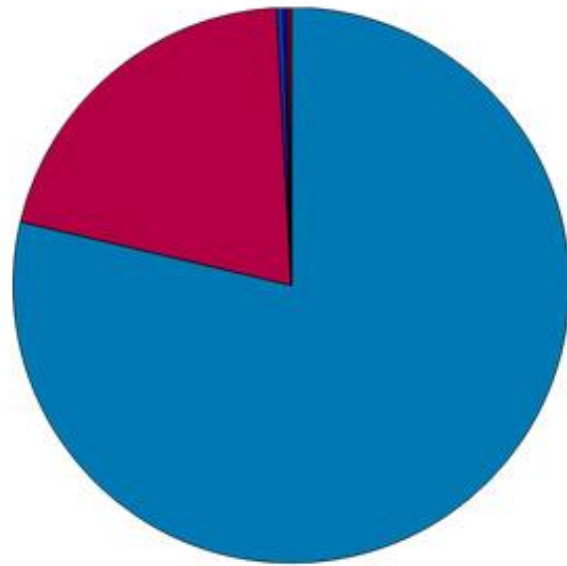
# Deposits Analysis by Scanning Electron Microscope

Carbon	78.66
Oxygen	20.50
Sodium	0.37
Iron	0.25
Calcium	0.22

Weight fraction

Element	Atomic %	Weight %
Carbon	83.36%	78.66%
Oxygen	16.31%	20.5%
Sodium	0.2%	0.37%
Iron	0.06%	0.25%
Calcium	0.07%	0.22%

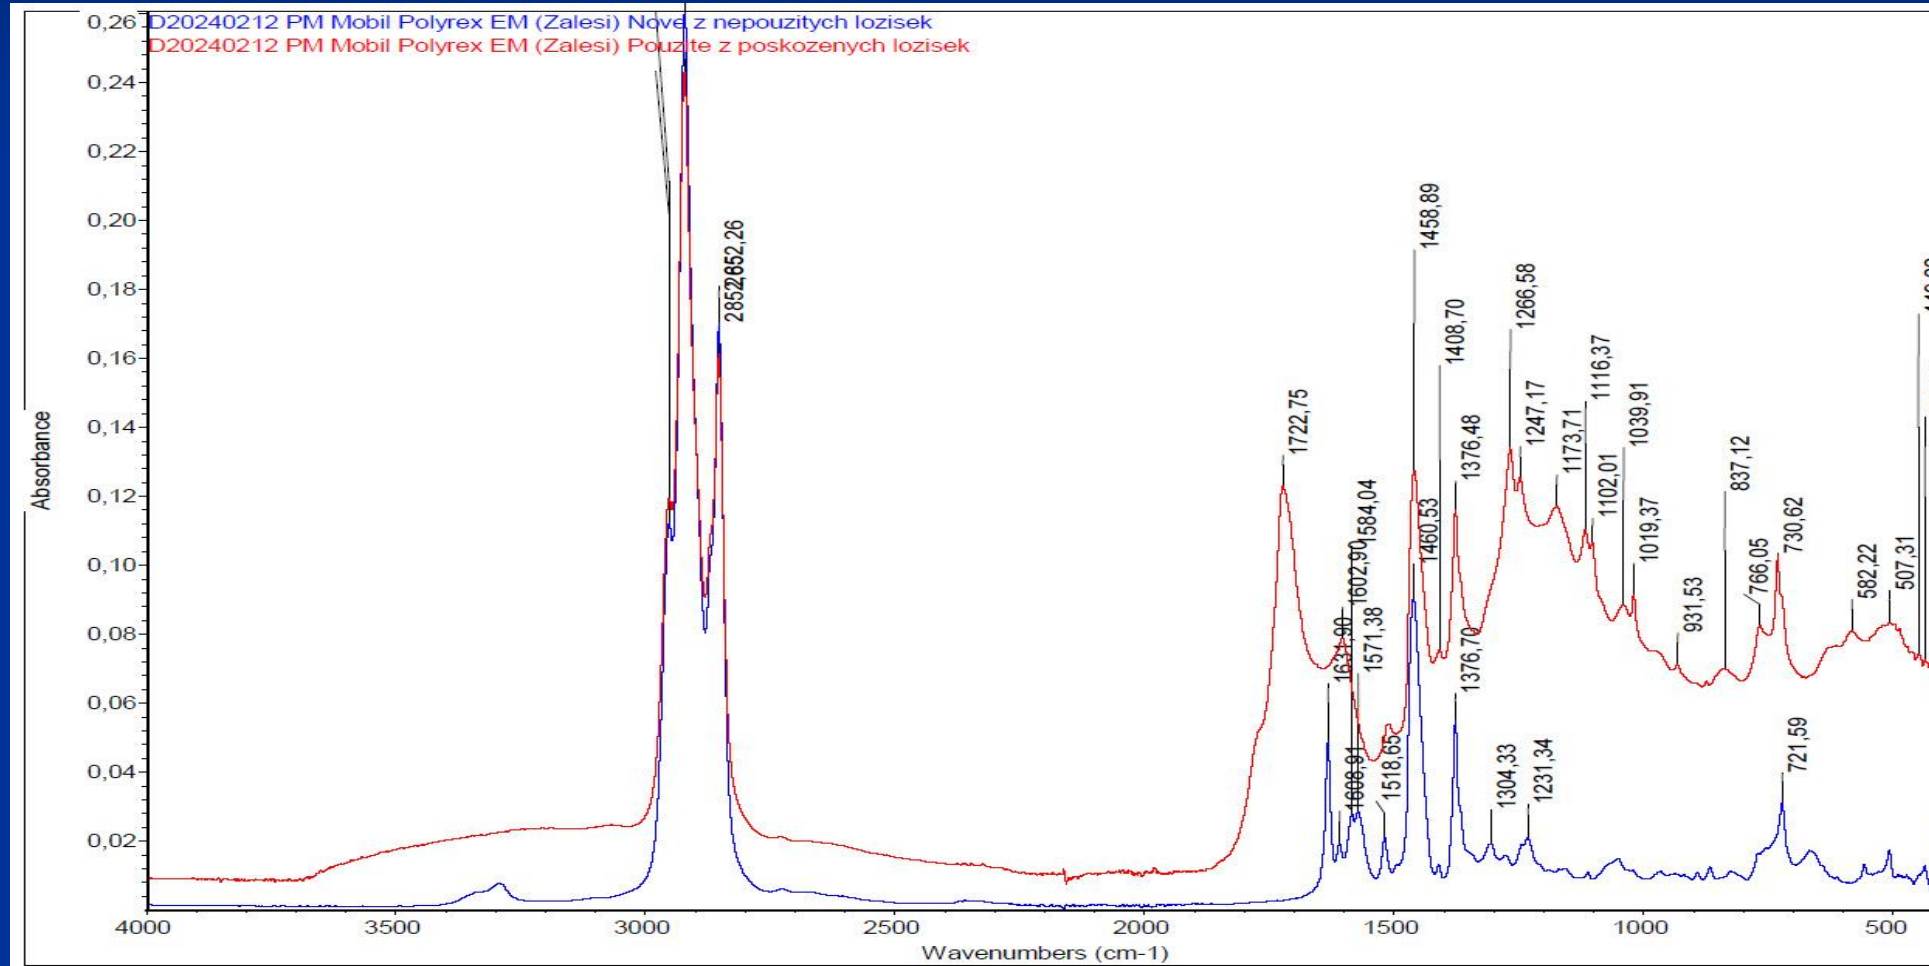
# FTIR ATR Analysis of Fresh PU Grease and Deposits

--- Deposits  
--- Fresh PU grease

- Too many suppliers, subcontractors and designers with poor communication among them.
- Bearings were ordered from different suppliers, nobody checked grease filling.
- All lubricating points were placed inside of drying oven, where the permanent temperature  $160^{\circ}\text{C}$  was too high for common lubricants.
- 1000 double sided bearings had not any possibility for relubrication.
- Chlorine traces were found in deposits, maybe from Plastisol decomposition. Chlorine causes corrosion and shortens the lifetime of lubricant.

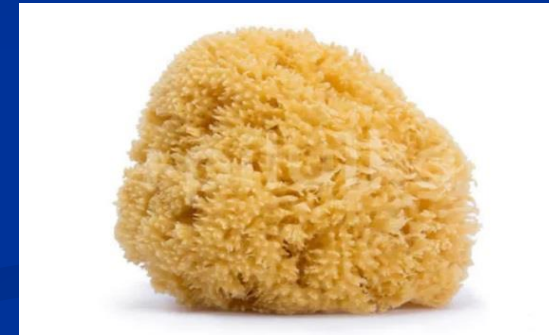
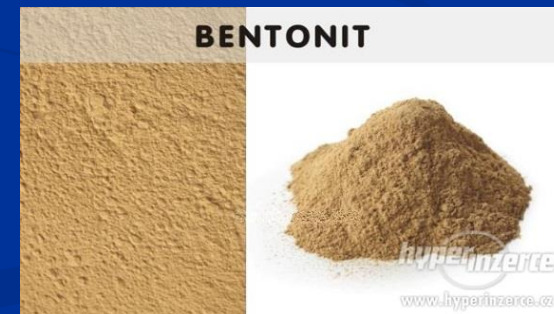
# Grease Temperature Resistance

**Short term** temperature resistance (only examples with mineral oil):

- Li thickener 140°C
- Li complex thickener 160°C
- Polyurea thickener 180°C
- Inorganic thick. (bentonite, gel) 200°C
- -----
- PFPE/PTFE 280°C
